Observational Study of Final Cleaning and AHERA (Asbestos Hazard Emergency Response Act) Clearance Sampling at Asbestos-Abatement Sites in New Jersey

PEI Associates, Inc., Cincinnati, OH

Environmental Protection Agency, Cincinnati, OH

Aug 89

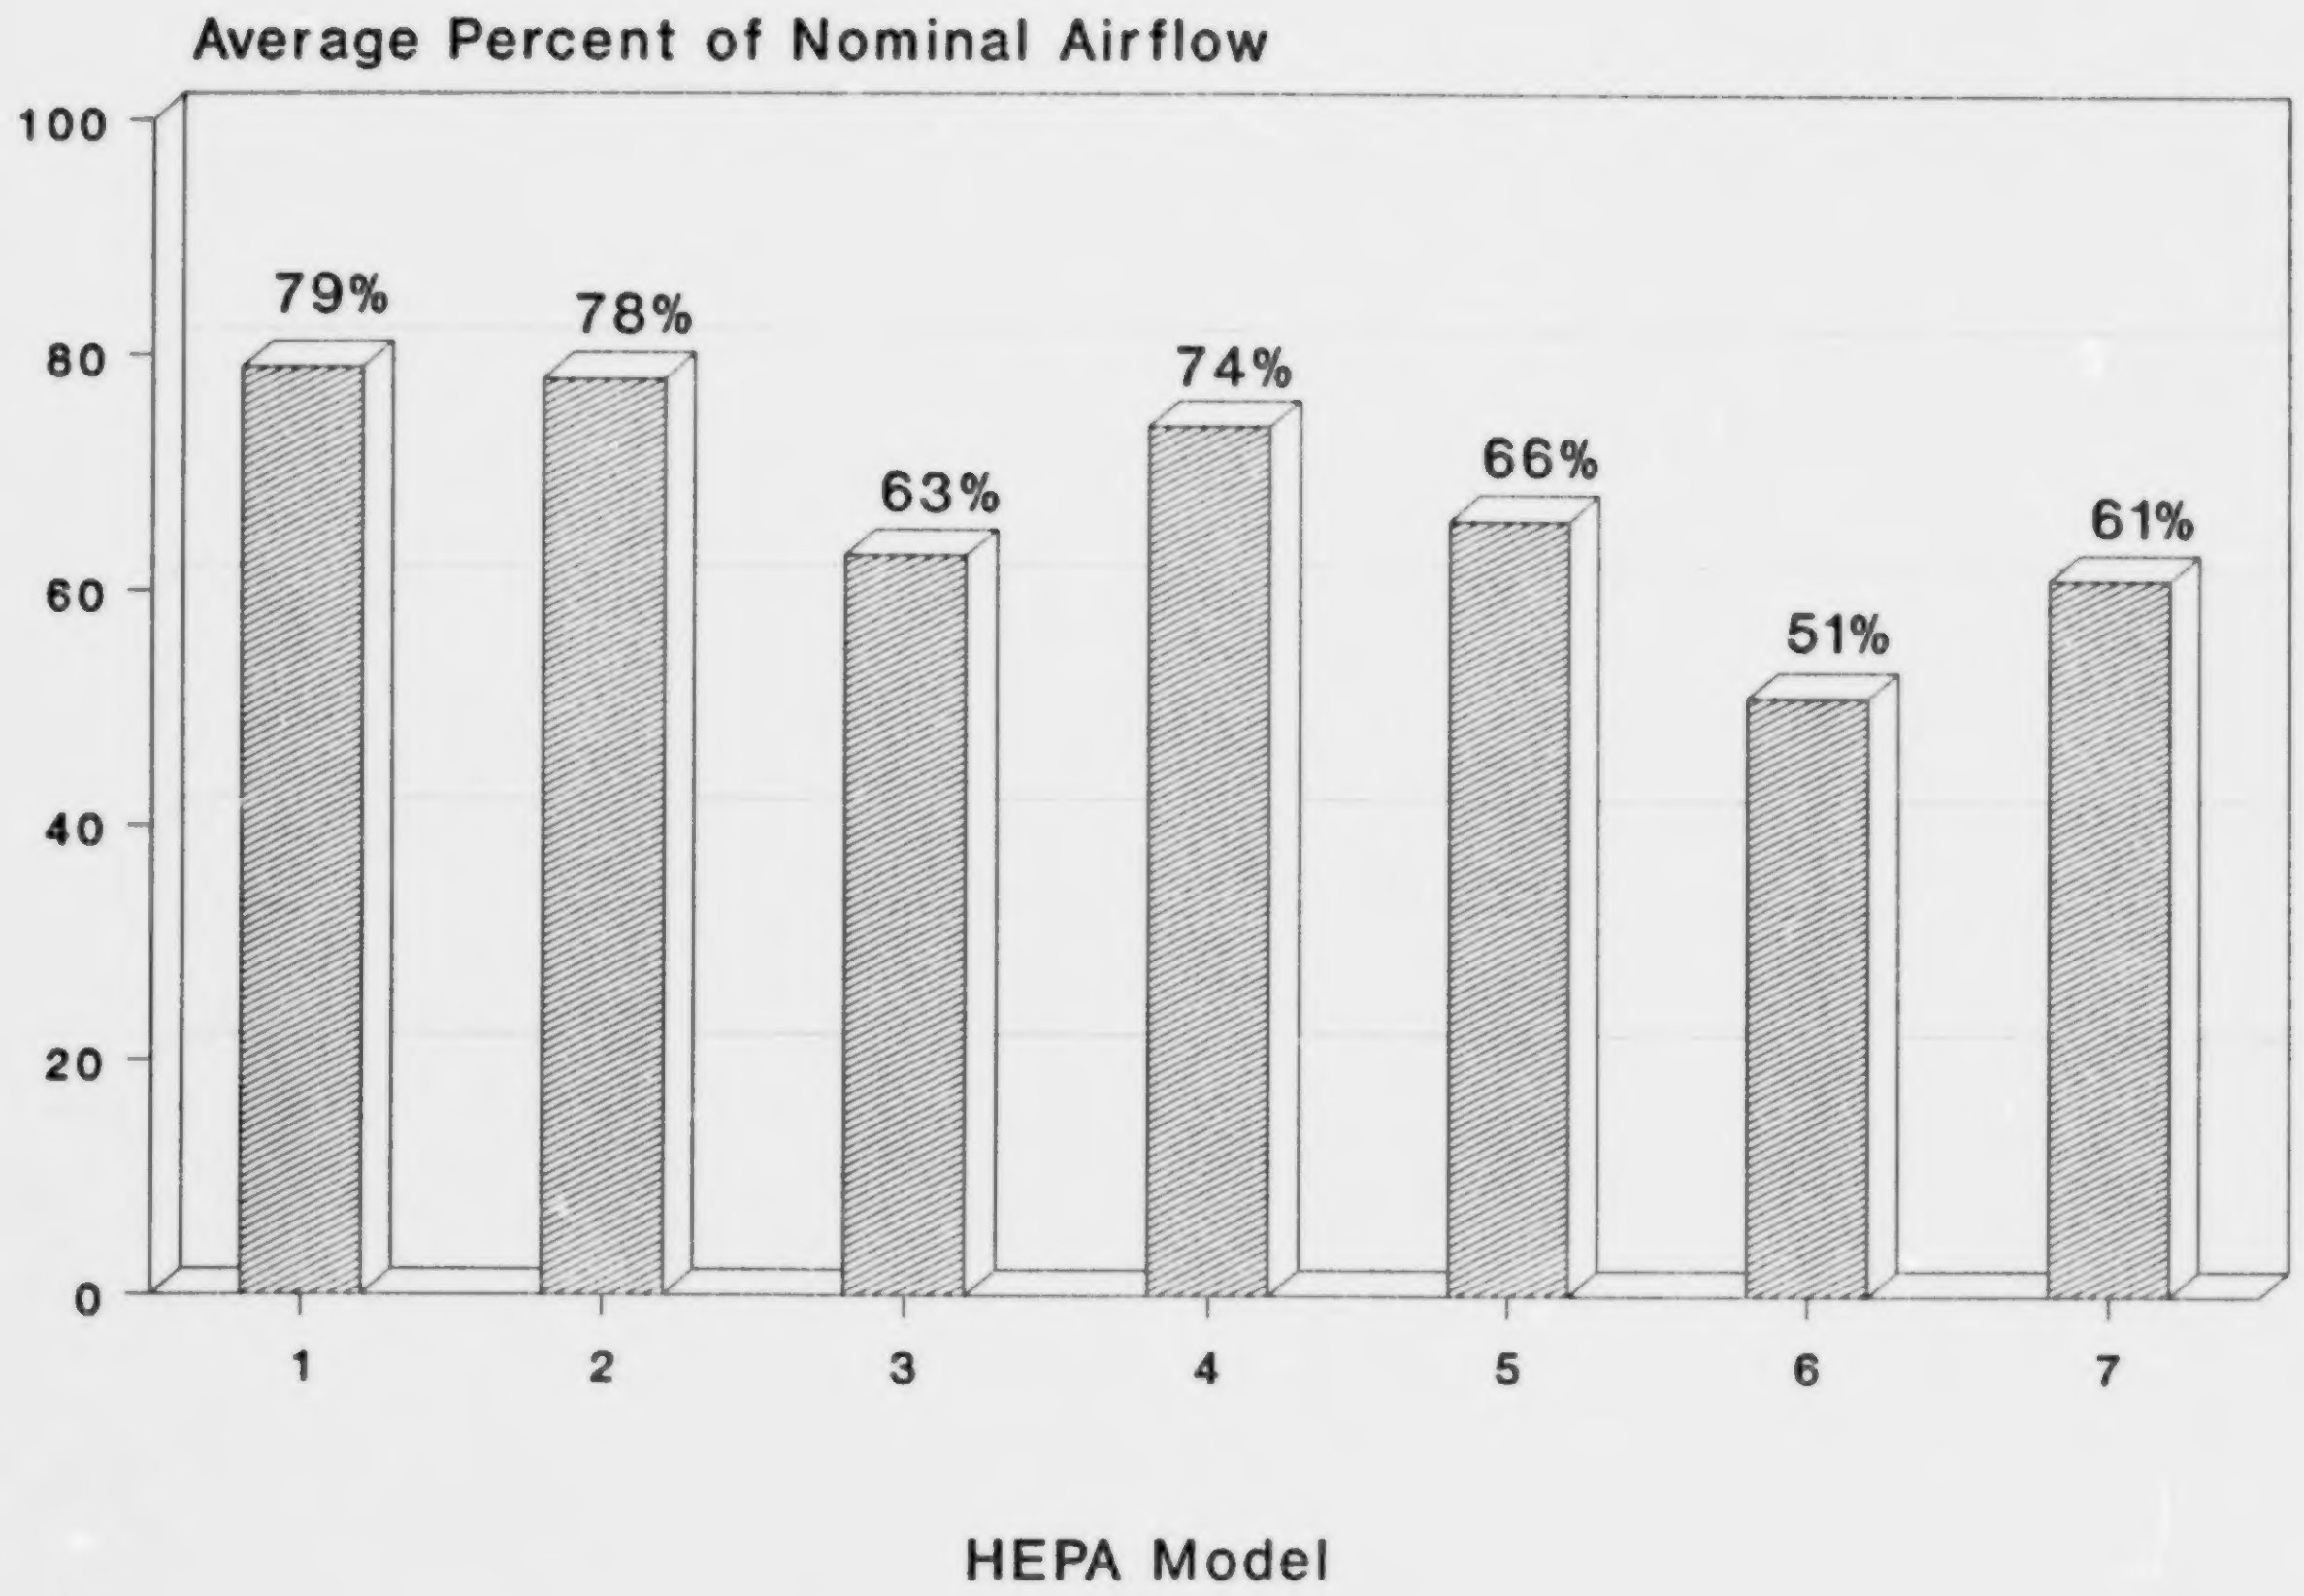
2) HEPA-filtration units used under normal operating conditions at asbestos abatement sites tend to perform below the manufacturer's nominal airflow. The average operating airflow ranged from 50 to 80 percent of the rated nominal airflow for 93 units representing seven model types.

Air-intake volumes for each HEPA-filtration unit in operation during final cleaning and AHERA clearance sampling were measured at each of the 20 sites in this study. Seven different models were observed and evaluated. The average operating airflow for each model was compared with the manufacturer's nominal airflow, i.e., the manufacturer's advertised rated peak capacity. Actual average operating airflow ranged from 50 to 80 percent of the nominal airflow for these models. This reduction in airflow performance is comparable to another study which showed a 50 to 60 percent reduction in airflow capacity.[4] Figure 1 illustrates the actual average operating airflow as a percentage of nominal airflow for the seven observed models. The reduced airflow performance of the filtration units is probably due to the increased static pressure associated with extended and obstructed exhaust duct conditions and to increased particulate loadings on the filters. The significance of this reduced operating flow rate is in the procedure used to determine the number of air-filtration units necessary to achieve the desired minimum ventilation rate (i.e., four air changes per hour). Assuming the air-filtration units are operating at the manufacturer's specified nominal airflow rate could result in actual ventilation rates significantly below project design specifications.

Figure 1. Airflow performance of HEPA filtration systems.

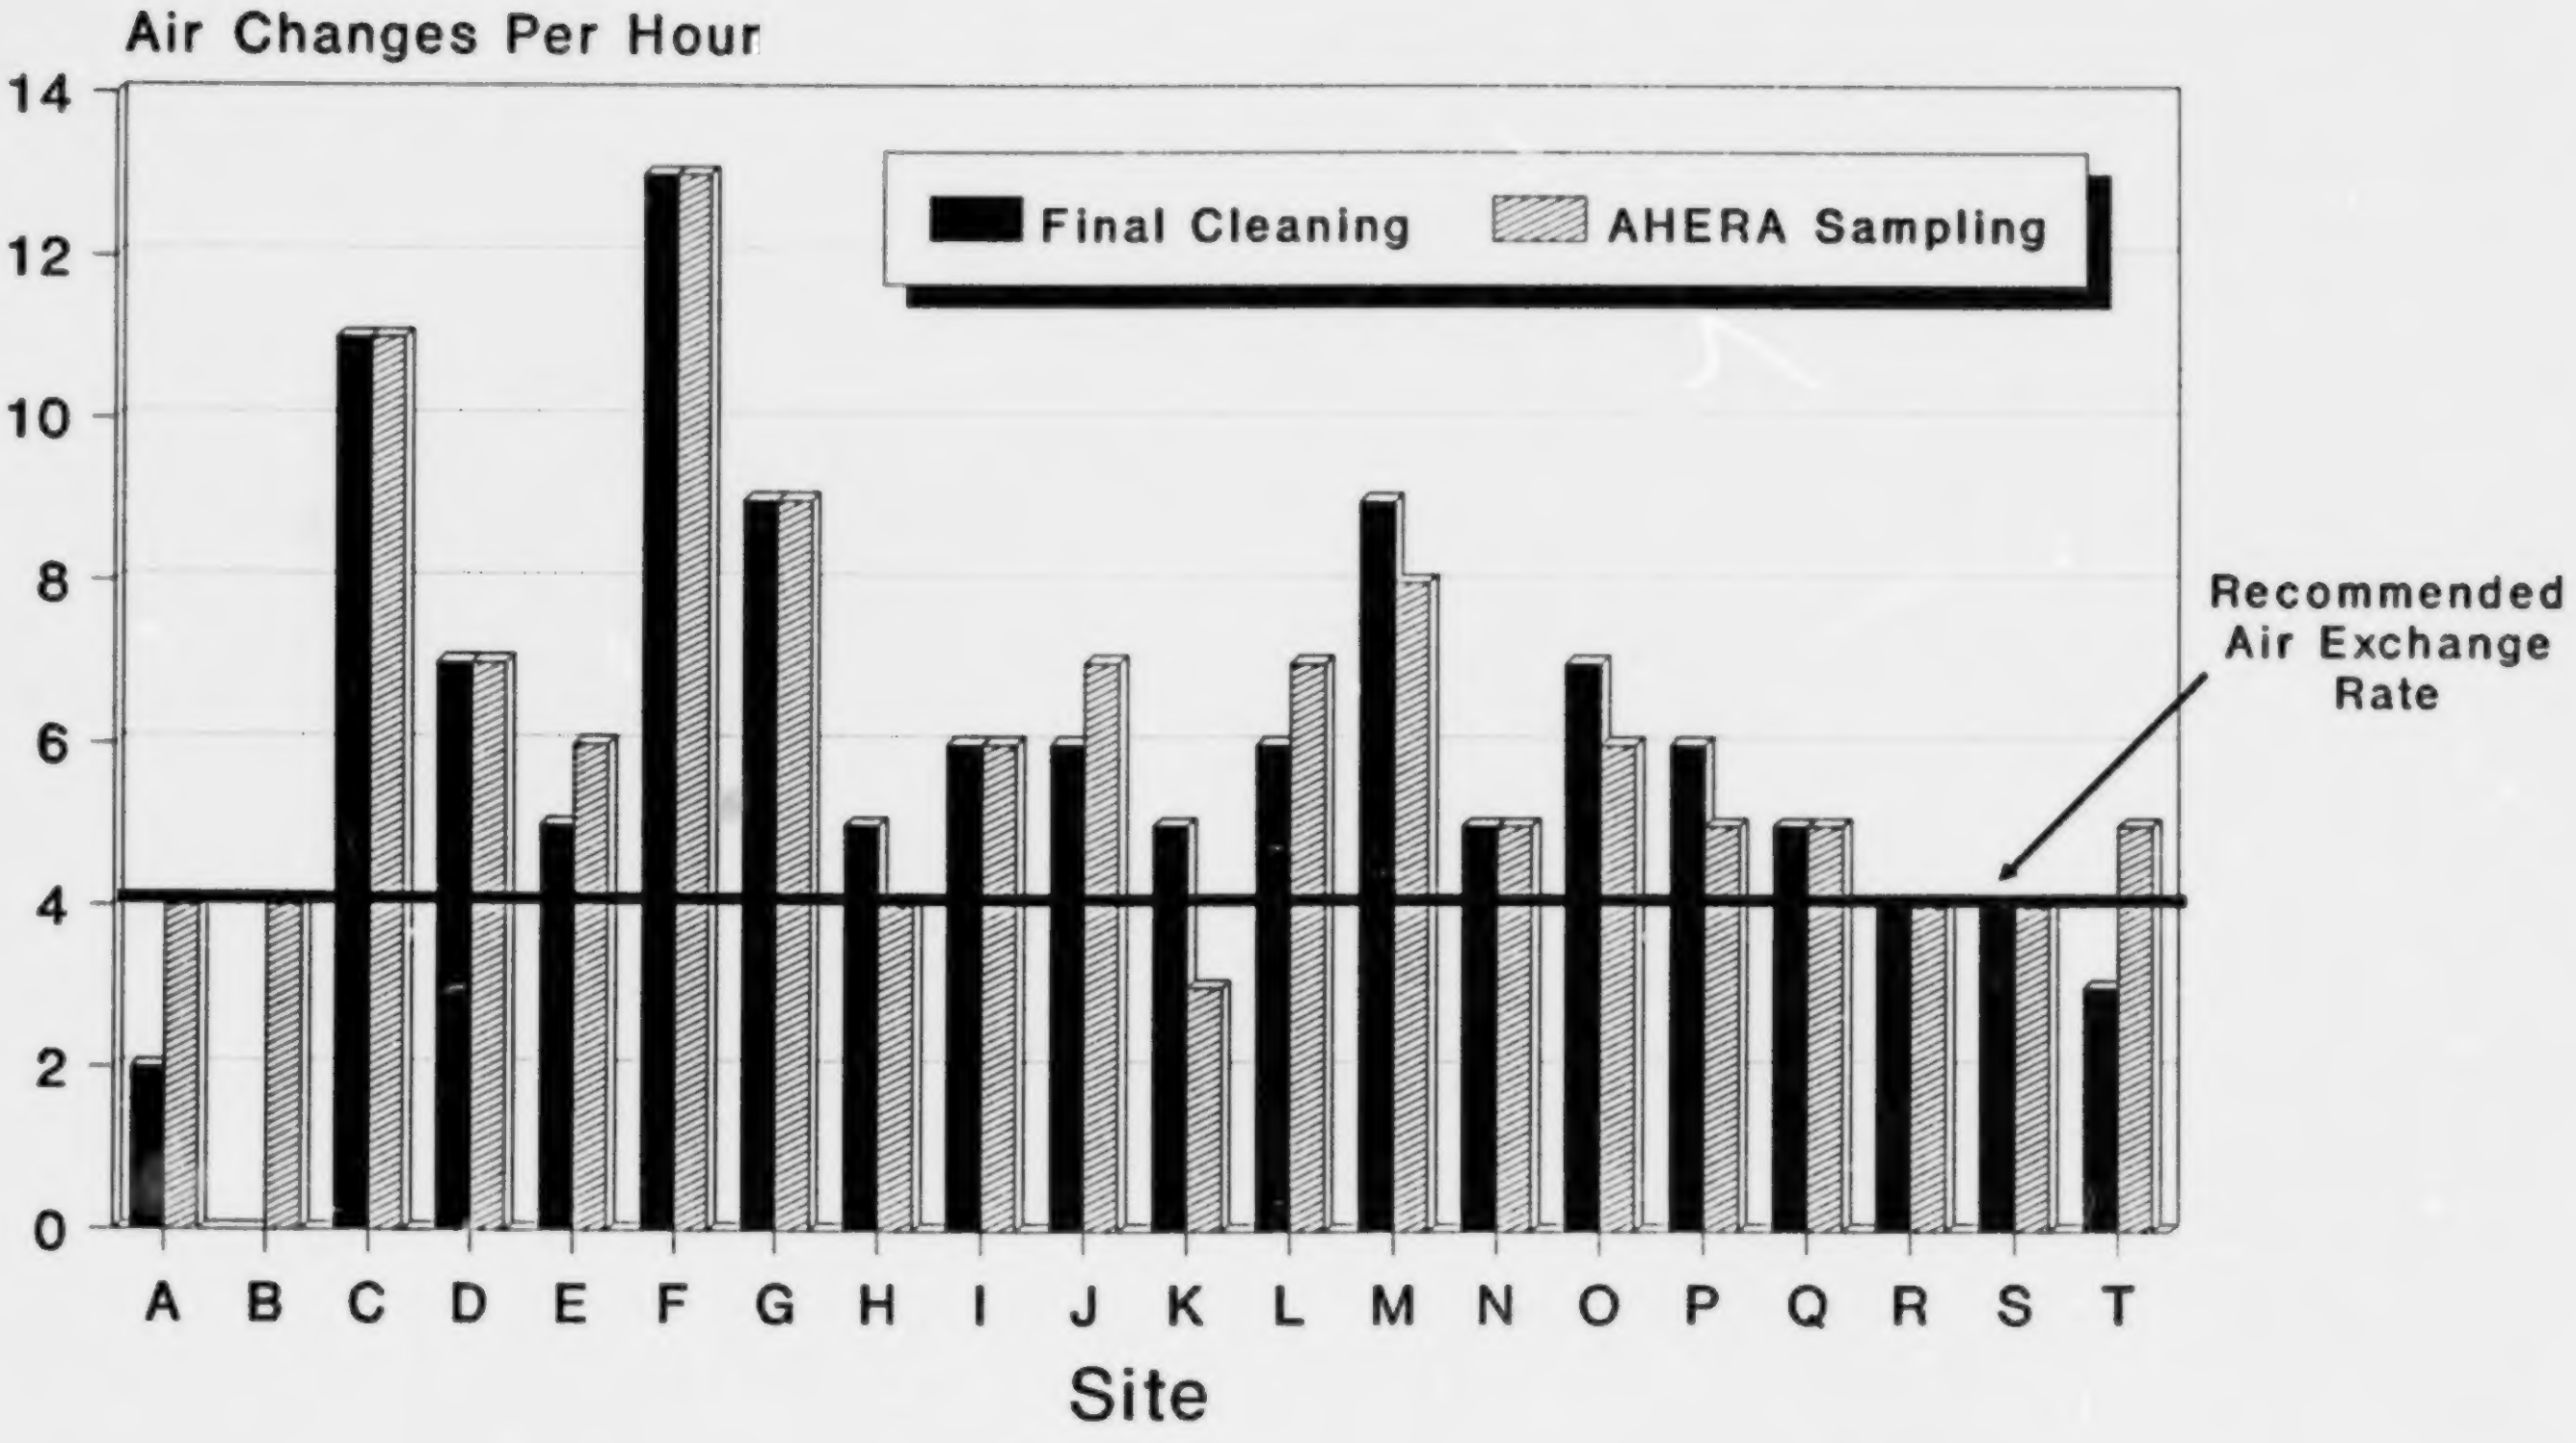
Despite the lower-than-assumed ventilation rates of the observed HEPA-filtration units, enough units were used at all but one site to achieve a minimum of four air exchanges per hour during AHERA clearance sampling. Also, only two sites failed to meet the recommended air-exchange rate during final cleaning. Figure 2 shows the air-exchange rates during final cleaning and AHERA clearance sampling at each of the sites. Actual air-exchange rates ranged from 2 to 13 per hour during final cleaning and 3 to 13 per hour during AHERA clearance sampling.

Figure 2. Air exchange rates in the abatement area at 20 asbestos abatement sites during final cleaning and AHERA clearance sampling.

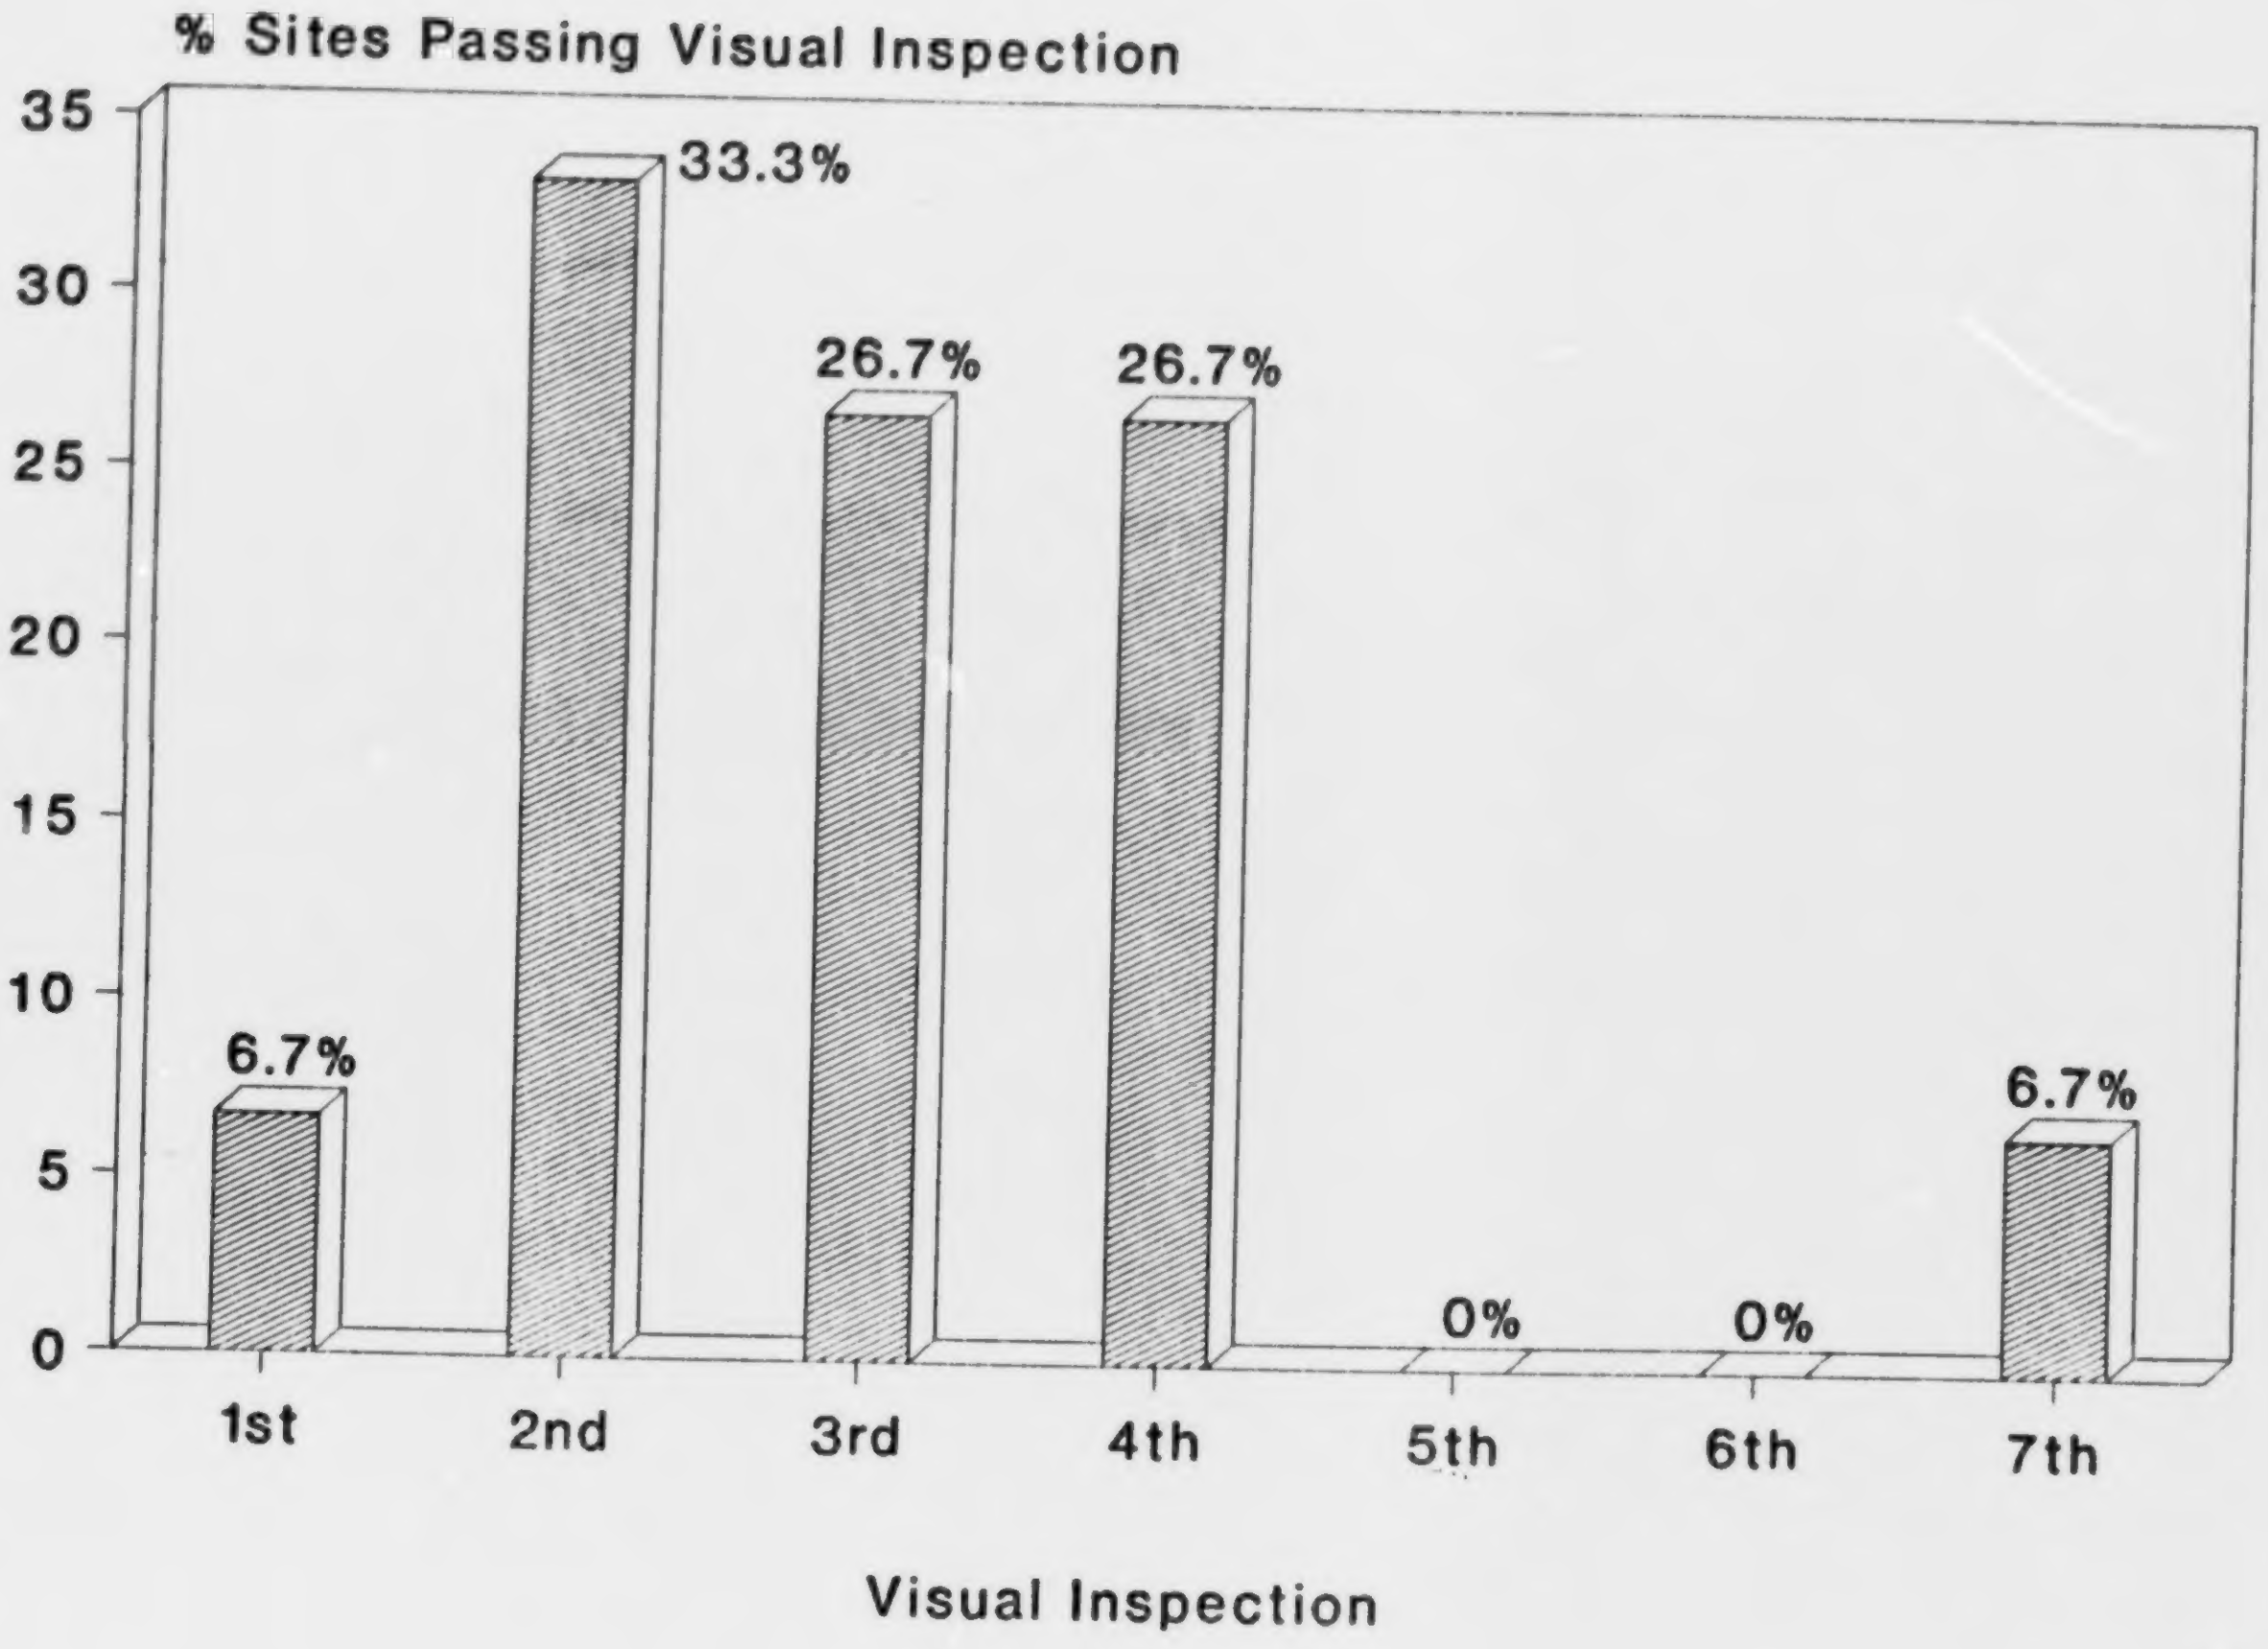
From one to seven visual inspections were conducted at each abatement site. Figure 3 shows the percentage of sites that passed the visual inspection per given attempt. The largest percentage of sites (33.5%) passed the visual inspection on the second attempt. The cumulative percentages of sites passing the visual inspection were as follows: 40 percent by the first and second attempts, 66.7 percent by the third attempt, and 93.4 percent by the fourth attempt.

Figure 3. Percentage of 15 sites passing the ACS's visual inspection for each attempt.

1) Procedures for visual inspections. This study suggests that work sites passing a stringent visual inspection are less likely to fail the clearance test and incur the expense of multiple rounds of sampling and analysis. Guidance for performing a thorough visual inspection would benefit both the building owner and abatement contractor.

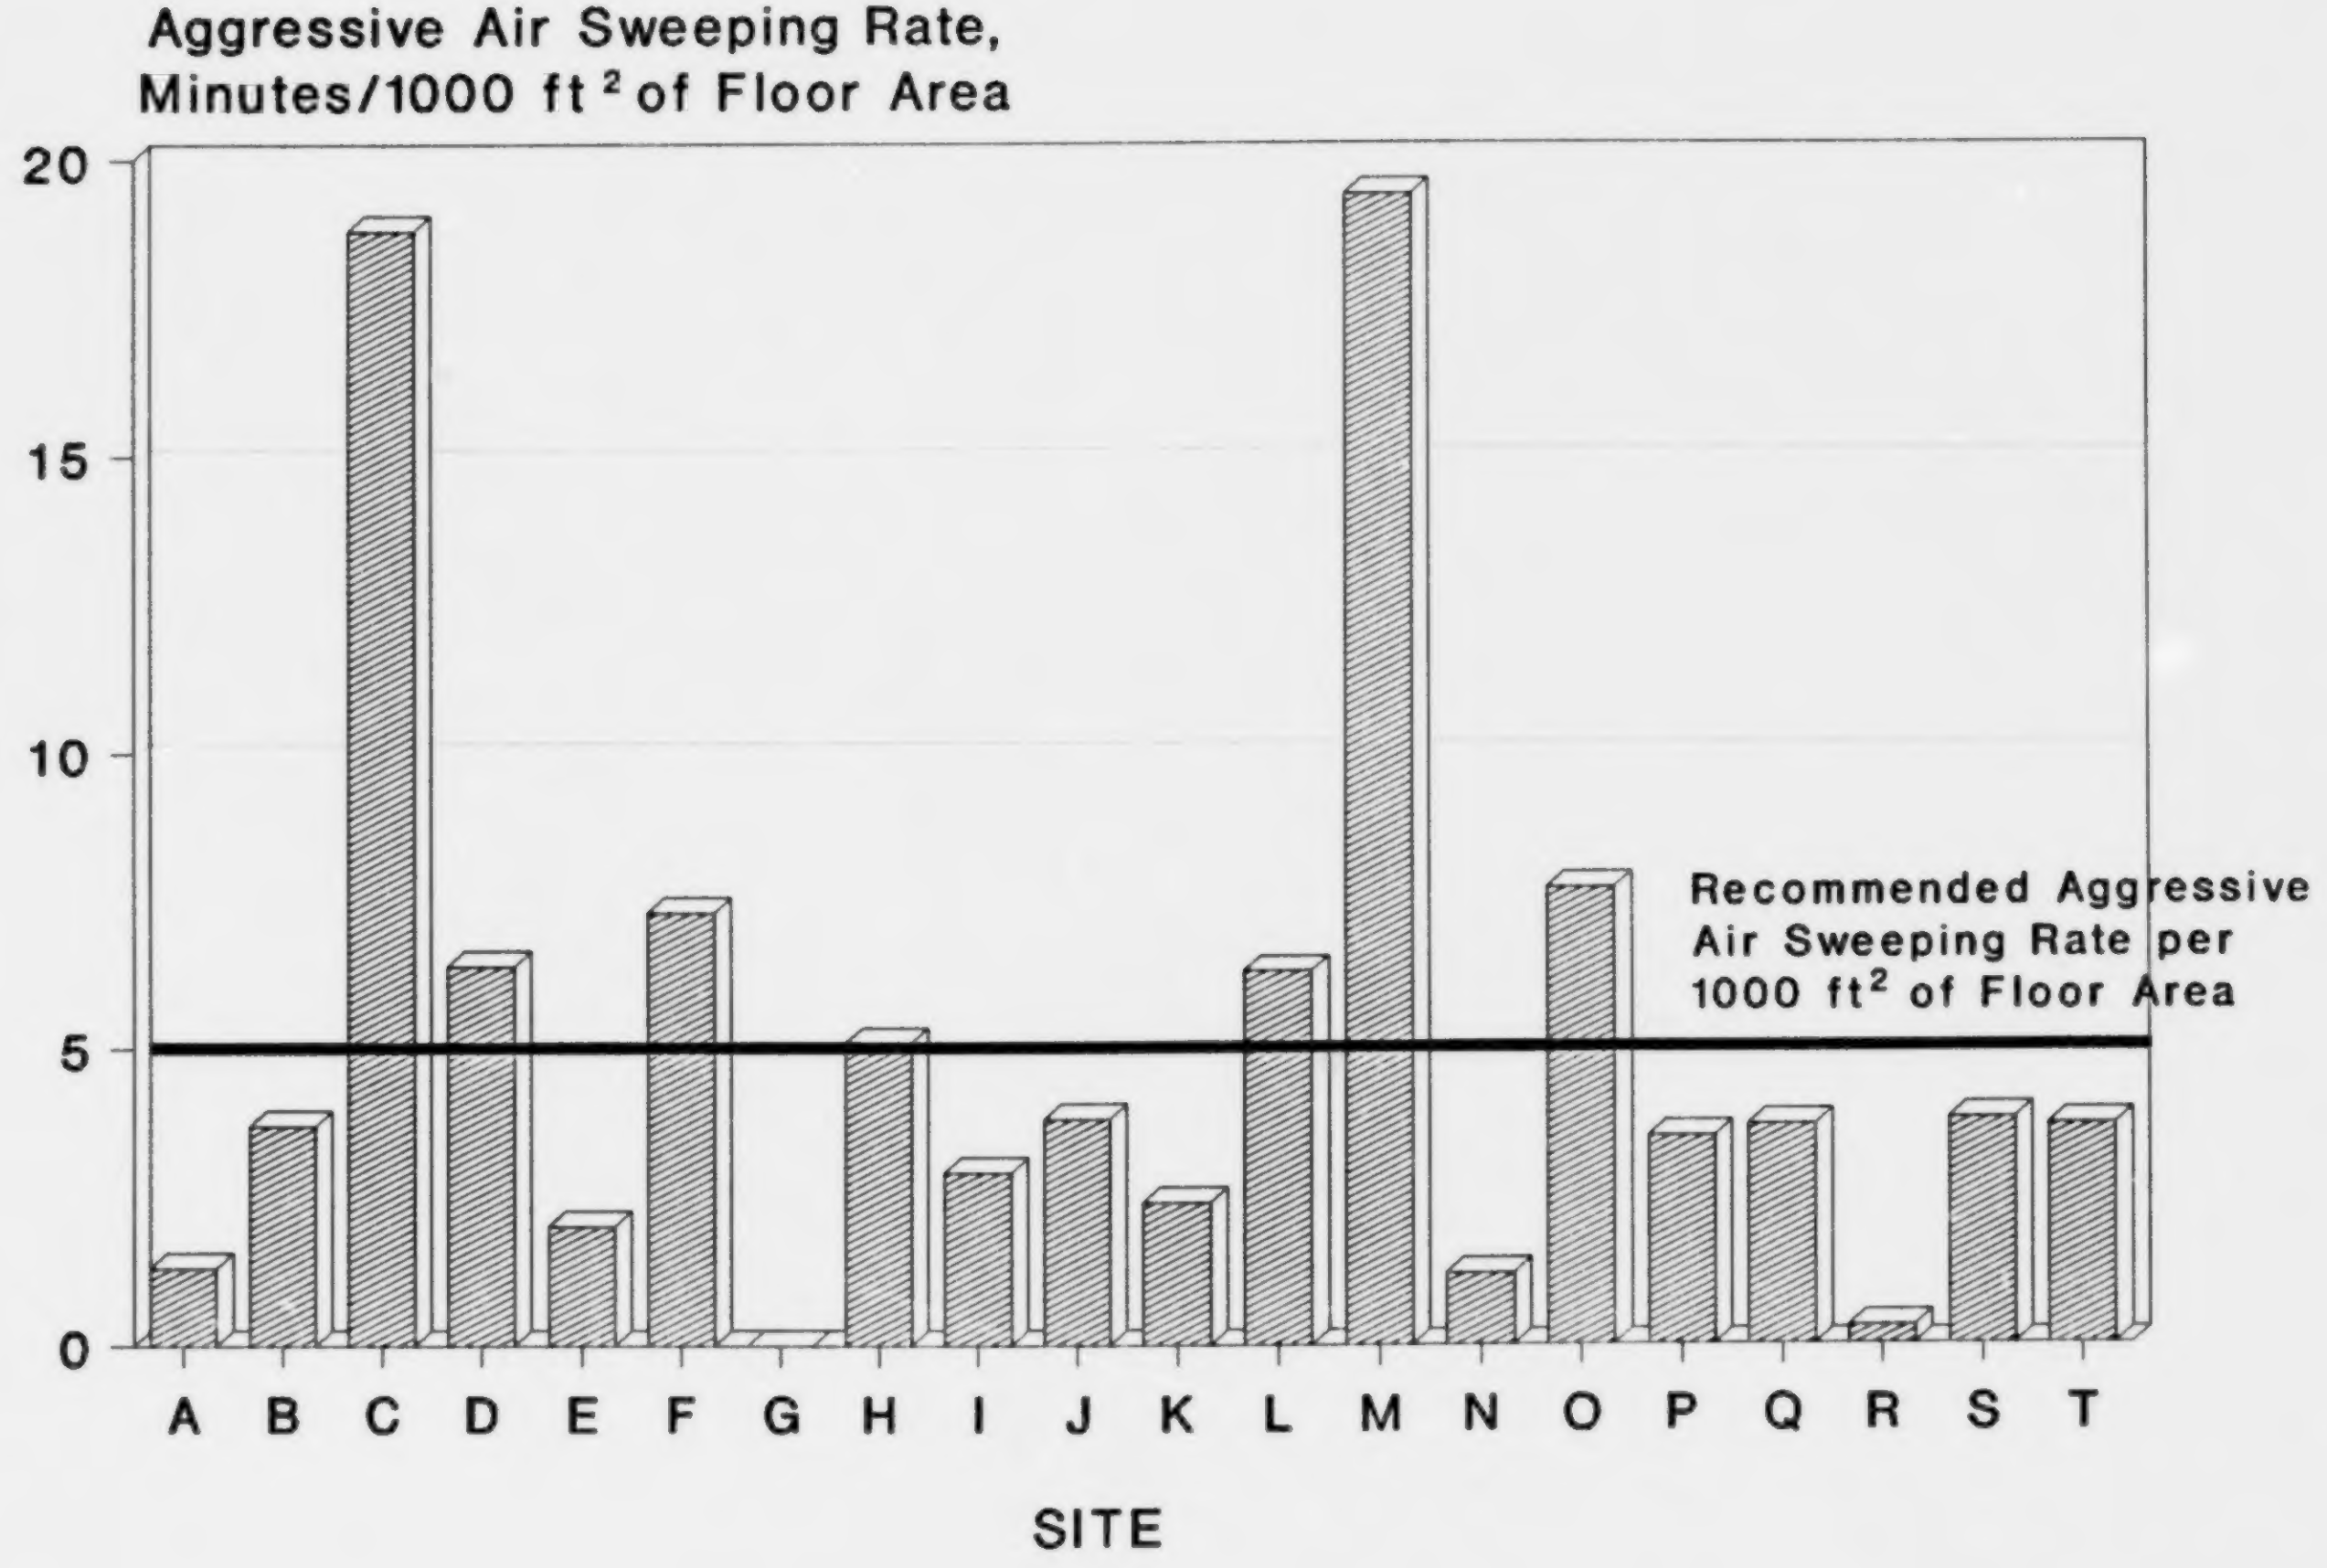
Figure 4. Observed aggressive sweeping times per 1000 square feet of floor area at 20 asbestos abatement sites.

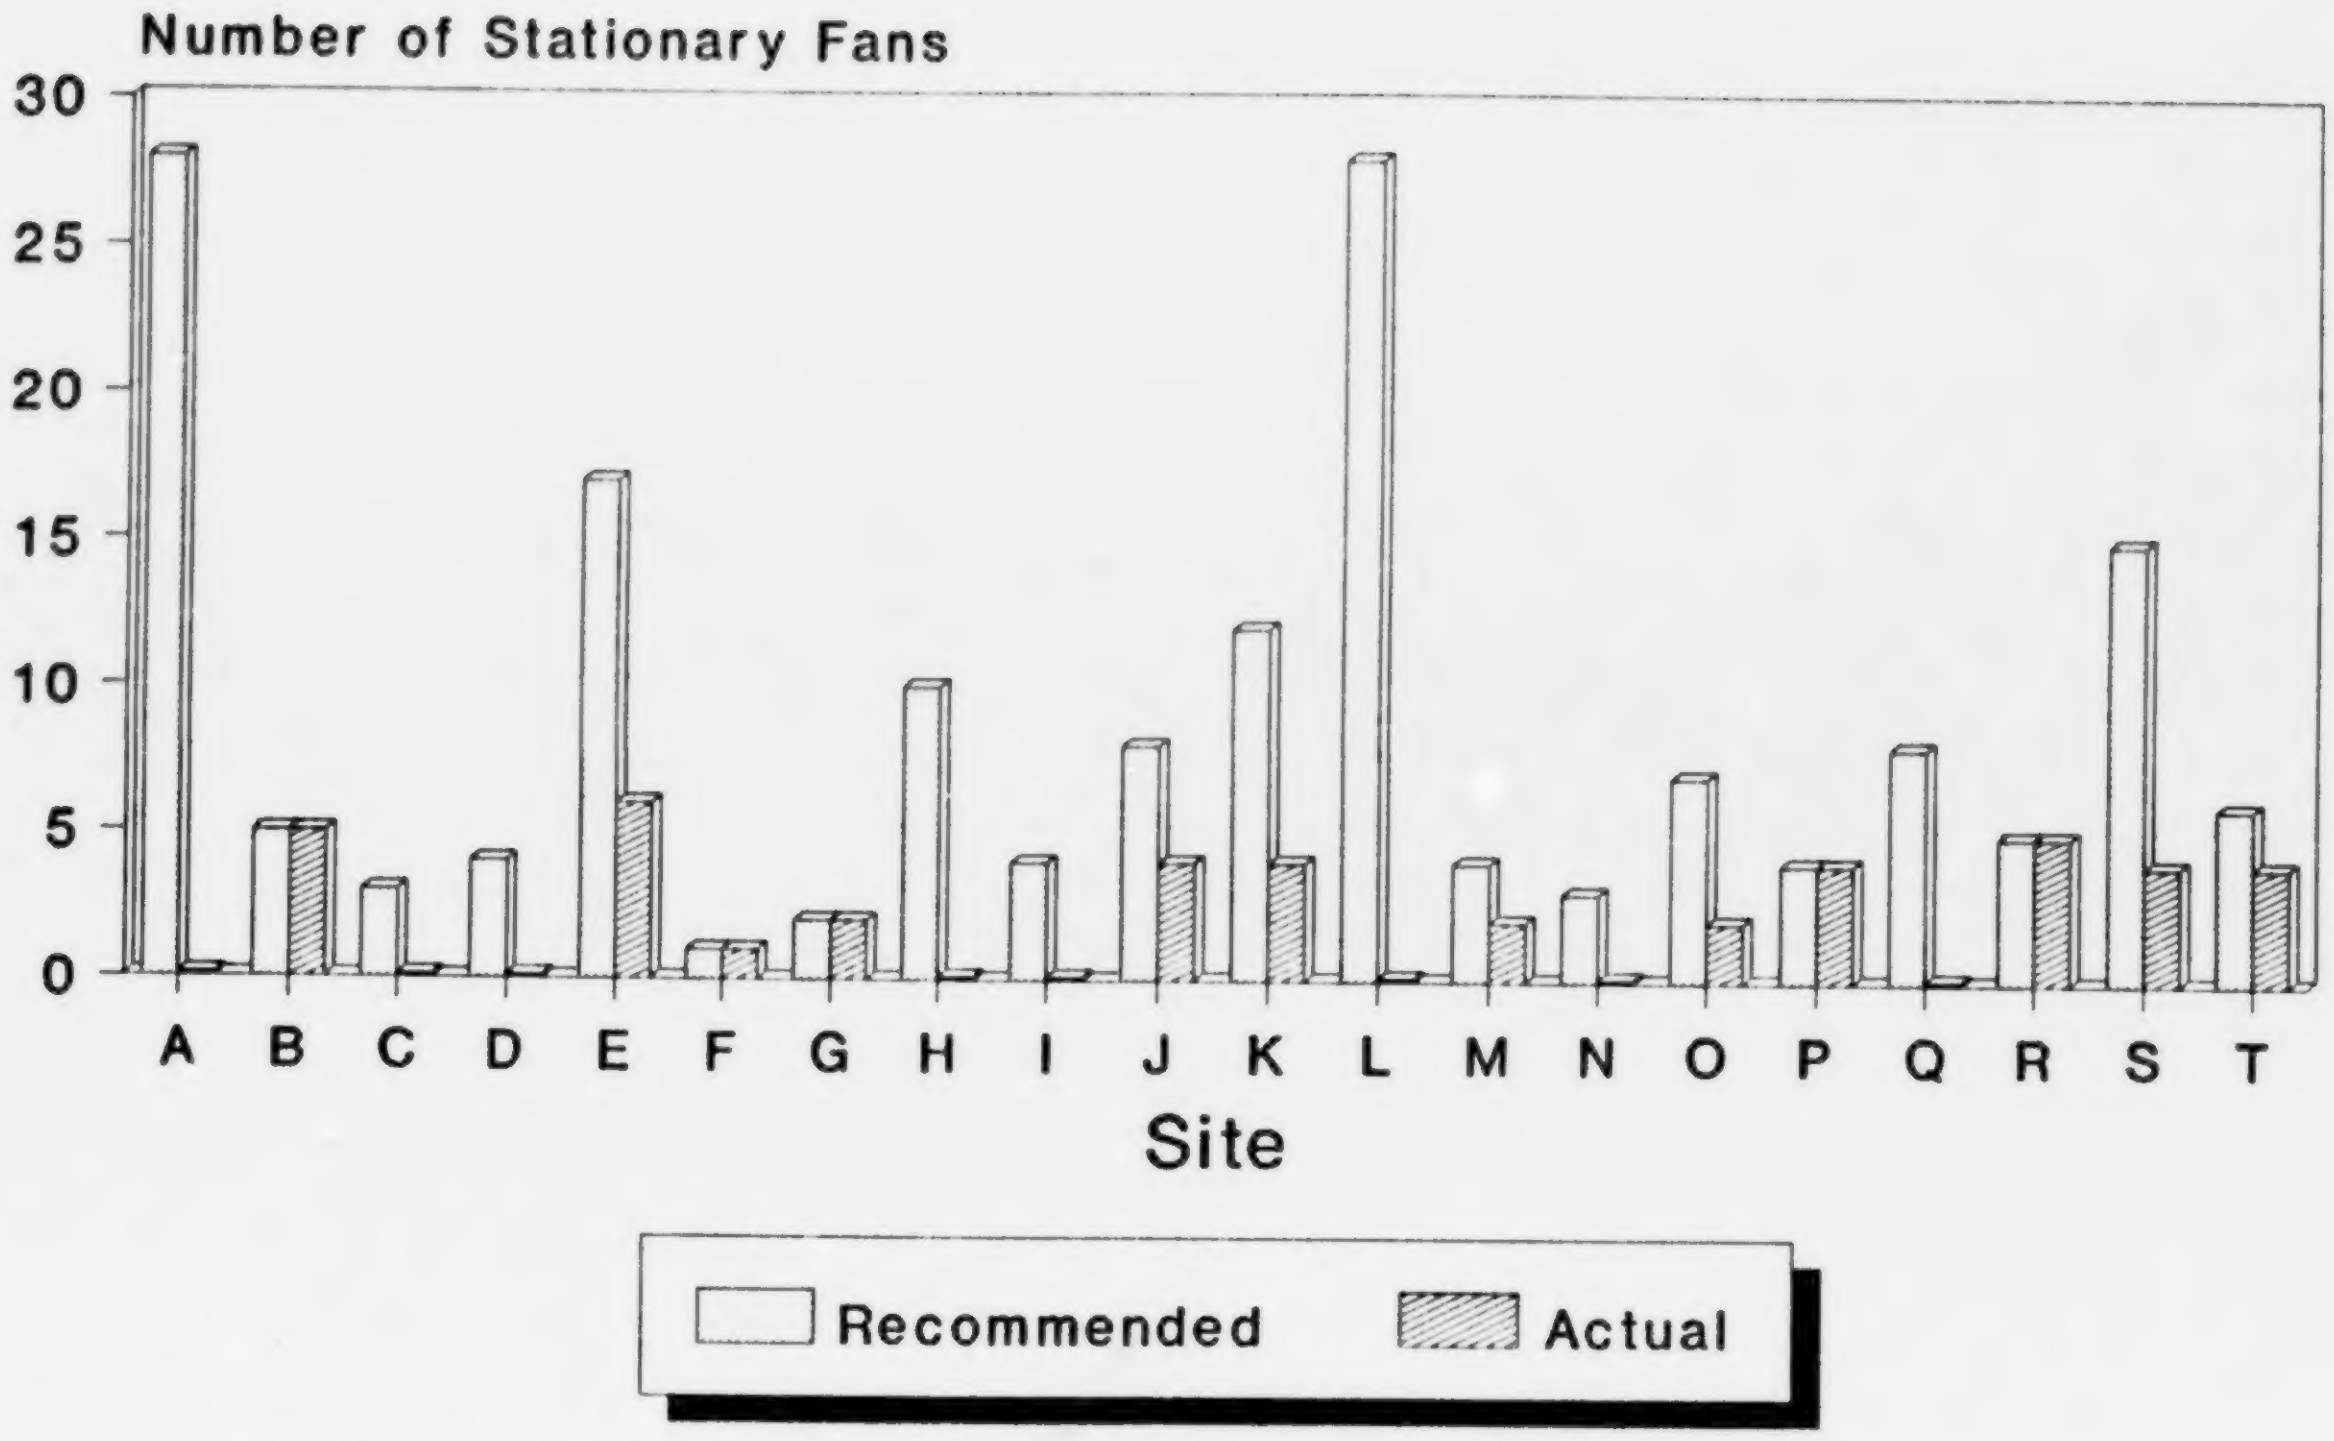
- Improper sampling media was used to collect clearance air samples, i.e., filter pore size at three sites and filter type at two sites.
- Recommended air sampling flow rates were exceeded at two sites.
- Phase contrast microscopy was improperly used to clear one site.
- Eight of the 20 abatement sites failed to meet the EPA-recommended drying time of 24 hours after completing final cleaning and before conducting final clearance air monitoring.
- Nineteen of the 20 abatement sites used aggressive air sampling techniques. Fourteen of these 19 sites failed to meet the EPA-recommended aggressive air sweeping rate of at least 5 minutes per 1000 square feet of floor area.
- Fifteen of the 20 abatement sites failed to use the number of circulating fans recommended by AHERA during final clearance air monitoring. No circulating fans were used at eight of the sites.

Figure 5. Recommended and actual number of stationary fans used during AHERA clearance air monitoring.
